Manhole Inspection Summary

Manhole # S27I__035MH

Location Address: **1016 W Pratt (alley behind house)**

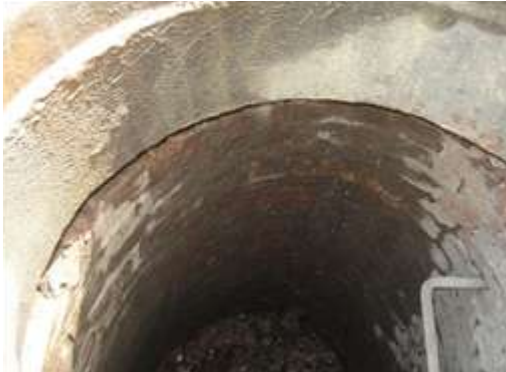
Defect 3

Infiltration: ☐ None ☐ Joint ☐ Cracks ☒ **Mortar** ☐ Roots ☒ **Wall**

corbel flow wall, corbel mortar

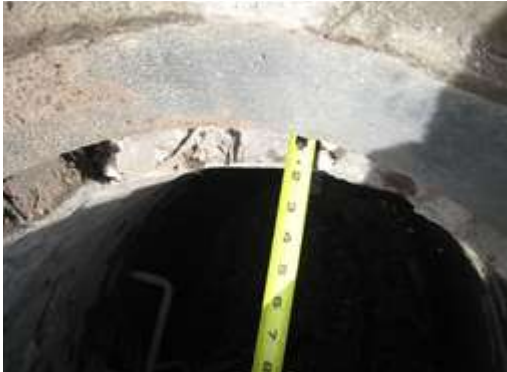
Defect 4

Frame Offset: **1.5** (in.) Condition: ☐ Sound ☐ Cracked ☒ **Leaks**

Frame offset 1.5" leaks

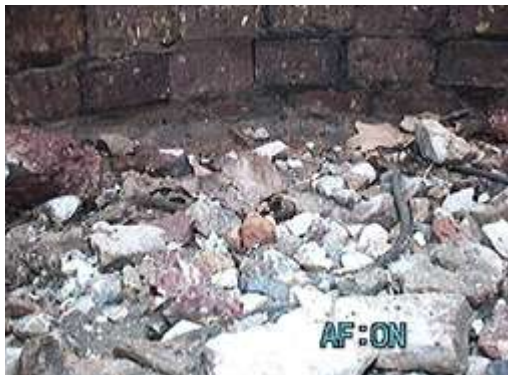
Defect 1

Condition: ☐ Sound ☐ Cracked ☐ Root Intrusion ☐ Deteriorated ☐ Leaks ☒ **Debris**

channel cond debris
